TECHNICAL EVALUATION
BOEING-VERTOL MODEL 347
ADVANCED TECHNOLOGY HELICOPTER

PHASE I

FINAL REPORT

US ARMY AVIATION SYSTEMS TEST ACTIVITY
EDWARDS AIR FORCE BASE, CALIFORNIA 93523

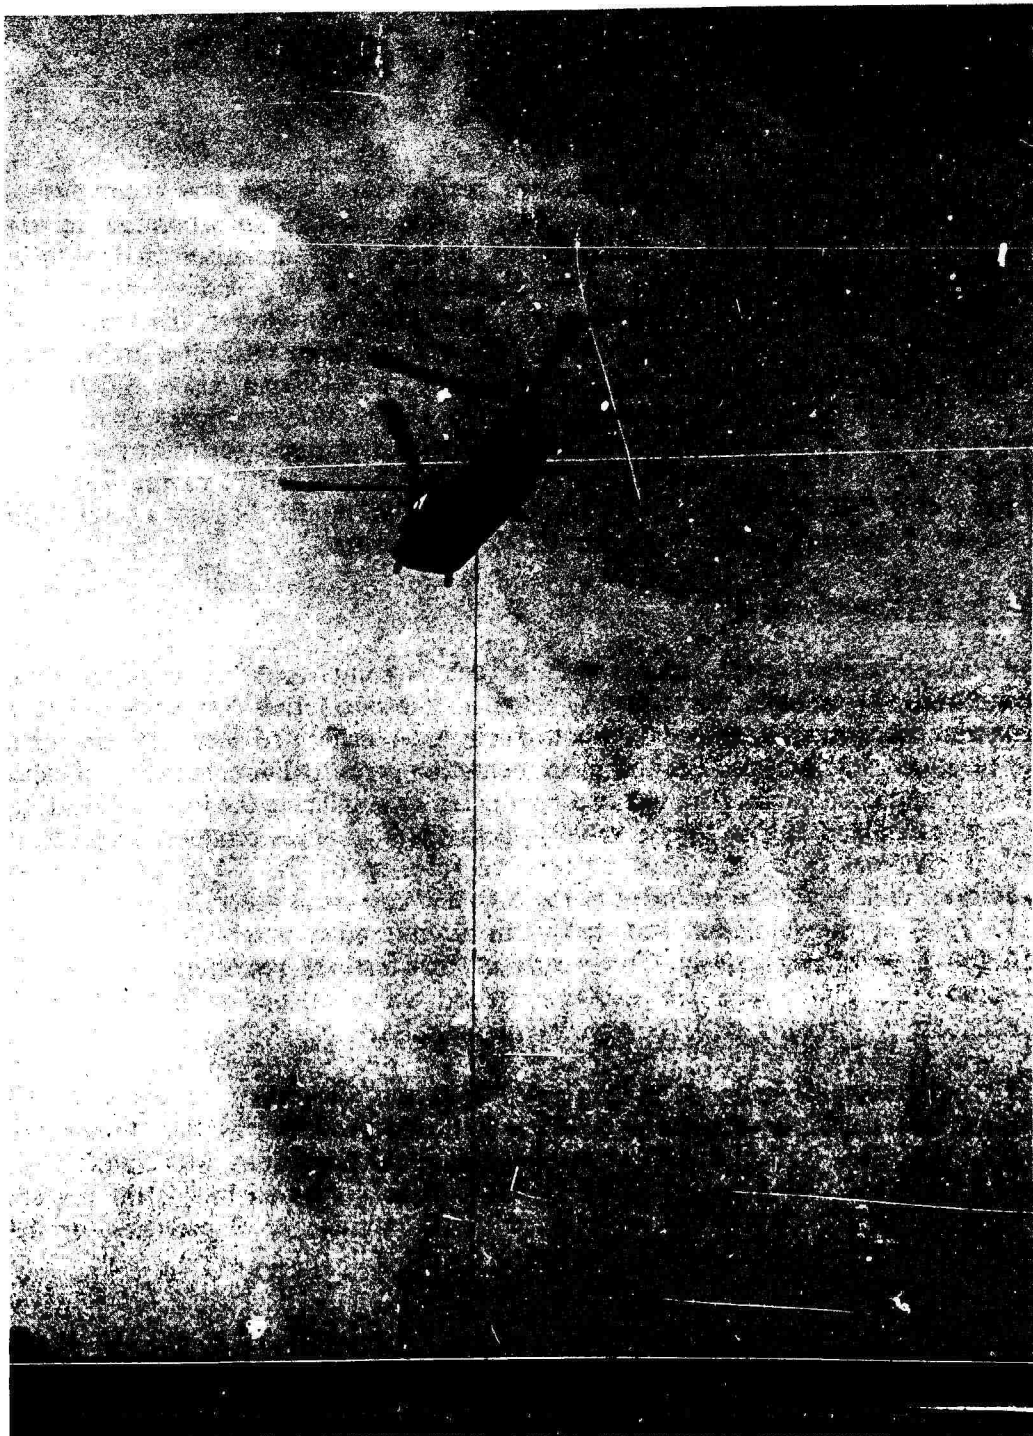
Photograph A. Tethered Hover Test Rig.

14. Out-of-ground-effect hover testing was accomplished at near sea-level conditions, at Millville, New Jersey, using a 150-foot tether line anchored to a concrete deadman, as shown in photograph A. A calibrated load cell was used to measure cable tension. Cockpit instrumentation permitted direct reading of cable tension and cable angle. The test was conducted by stabilizing the load cell reading, at predetermined engine torque values, up to the engine gas producer speed limit (N_1). This was done at a constant referred rotor speed (N/rpm) of 219 rpm. In addition, data were also recorded at the high and low rotor speed limits (235 and 215 rpm) at the minimum and maximum aircraft gross weights of 34,790 and 50,180 pounds, respectively. The results of this test are presented in figure 1, appendix II. The results are also summarized and compared with the CH-47C helicopter test results (ref 16, app II) in figure A.

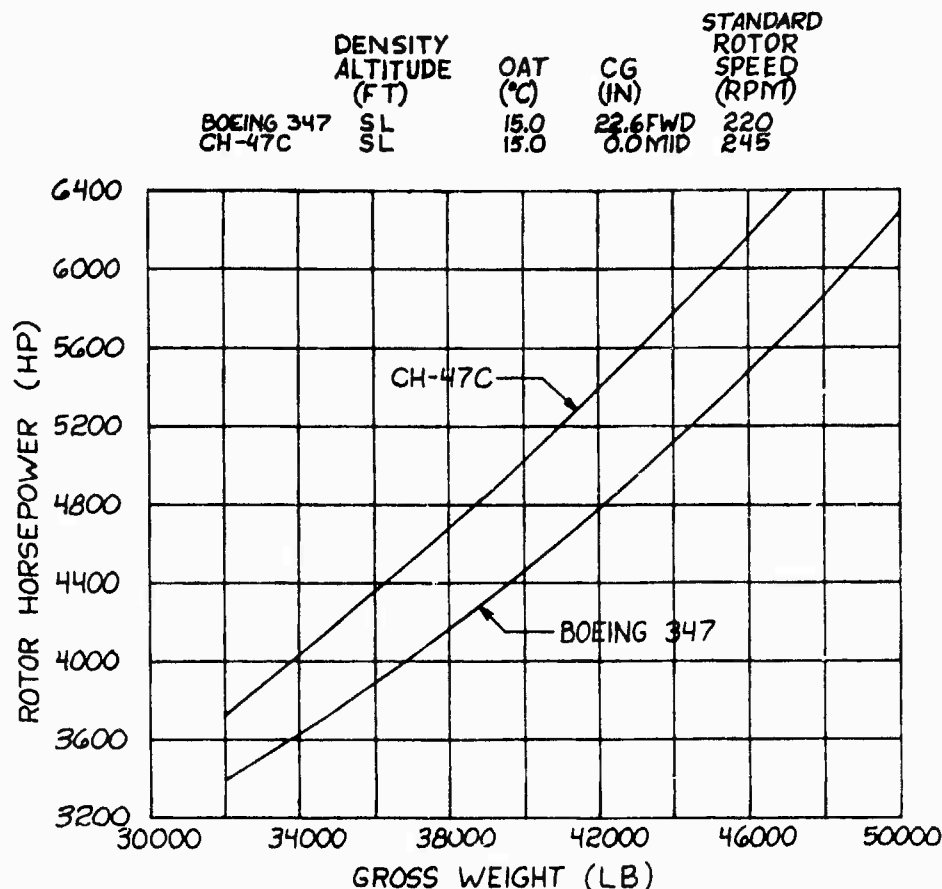
Figure A. Out-of-Ground-Effect Hover Performance Comparison.

15. As shown in figure A, at any given constant rotor shaft horsepower, the Model 347 helicopter can hover OGE at a higher gross weight than is possible with the CH-47C helicopter. At sea-level, standard-day conditions, with 6,000 rshp, the Model 347 can hover OGE at 48,700 pounds compared to 45,100 pounds for the CH-47C. This is an increase of 3,600 pounds, or 8 percent, for the Model 347 helicopter.

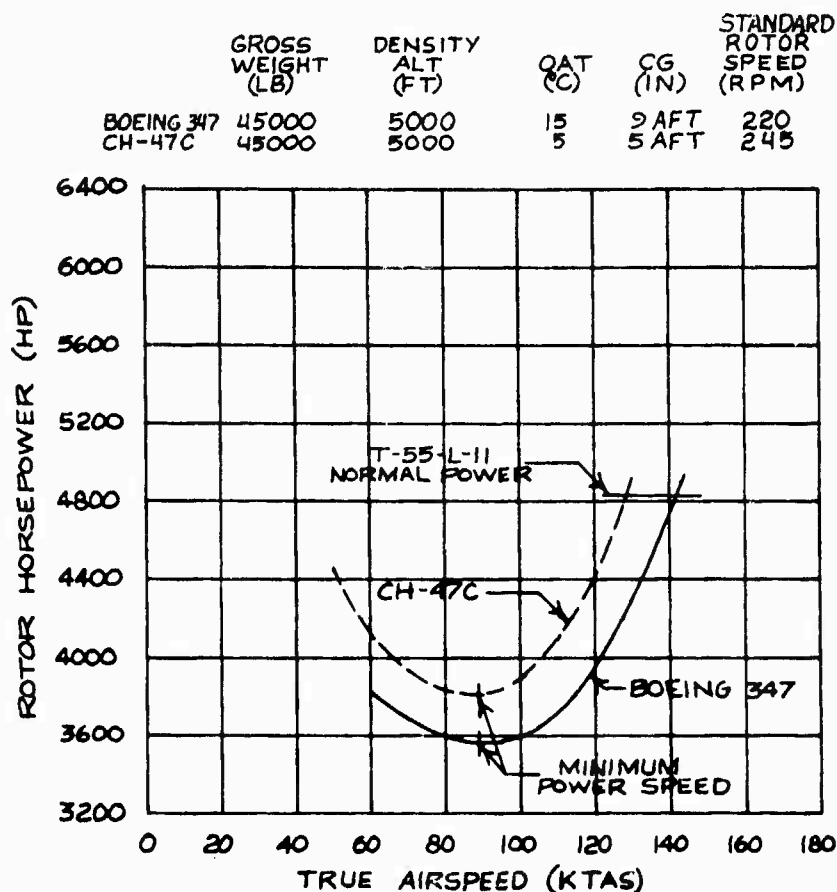
Figure B. Level Flight Performance Comparison.

of the Model 347 is 141 KTAS, an increase of 12 knots, or 9 percent, over the 129 KTAS of the CH-47C. This increase in NRP cruise speed would produce an approximate 9-percent increase in specific range for the Model 347 at an average mission gross weight of 45,000 pounds. Under the same level flight operating conditions at the speed for minimum power required (approximately 88 KTAS for both aircraft), the Model 347 required 3,550 rshp compared to 3,850 rshp required for the CH-47C. This is a decrease of 300 rshp, or 8 percent, for the Model 347 helicopter.

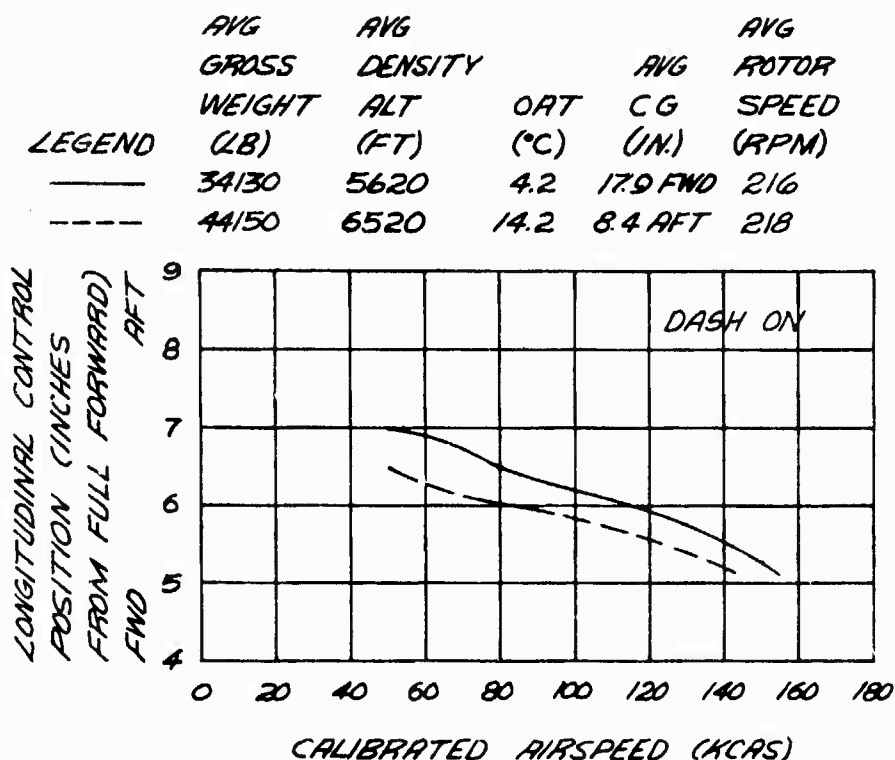
Figure C. Model 347 Static Trim Characteristics.

49. The longitudinal control trim position gradient in level flight was stable and essentially linear throughout the tested airspeed ranges. As shown in figure C, large changes in weight and cg had only a minor effect on the longitudinal trim gradient. The total control travel, from 50 to 142 KCAS, was approximately 1.4 inches forward at the aft cg loading. Under similar conditions, the CH-47C trim control gradient was unstable, and the control travel over the same airspeed range was approximately 0.7 inch aft. The stable and consistent longitudinal control trim gradient of the Model 347 helicopter decreased pilot workload in changing airspeed and allowed rapid and accurate trimming at any desired airspeed (HQRS 2). This was particularly evident during flight under simulated IFR conditions. Extension or retraction of the landing gear at any trim speed required less than 0.1 inch of longitudinal control motion to maintain the trim airspeed.

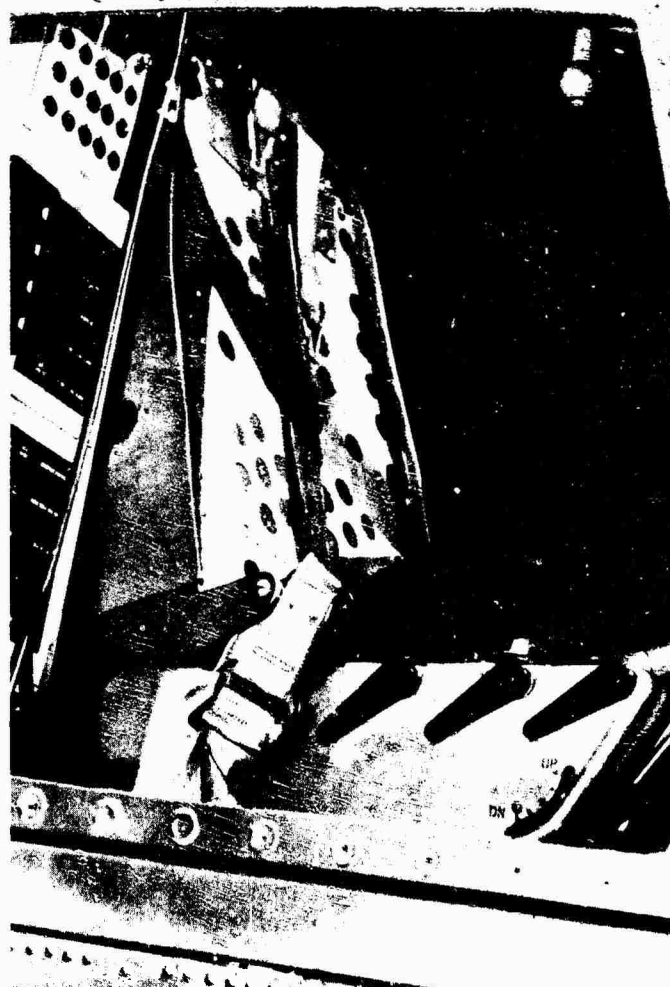
Photograph B. Side View of Pilot Seat.

86. The pilot and copilot seats installed in the Model 347 helicopter provided four adjustments: fore and aft, up and down, seat back recline, and upper leg support. Photograph B is a side view of the pilot seat showing the locations of the adjustment release handles. The seat was easily adjusted to fit the pilot and provided excellent support. The upper leg support adjustment, which controlled the height of the forward portion of the seat bottom, was of particular benefit in reducing leg fatigue and allowing adequate blood circulation to the lower extremities.

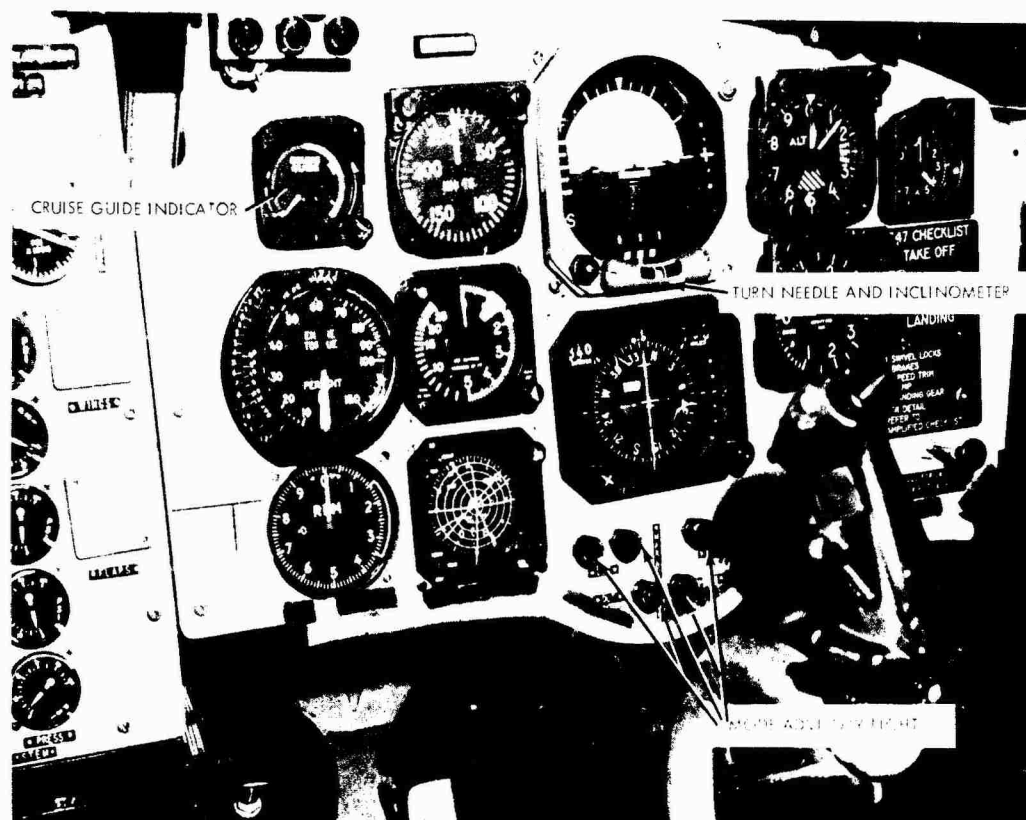
Photograph C. Pilot Instrument Panel.

88. The pilot turn needle and inclinometer were integrated into the lower portion of the flight director case, as shown in photograph C. The small size of the turn needle and inclinometer prevented the pilot from quickly and accurately reading and interpreting these instruments. A larger-size turn needle and inclinometer are desirable for improved helicopter operation.

89. As shown in photograph C, mode advisory lights, indicating the status of the VHF navigation receivers and automatic flight path coupler, were located at the bottom edge of the pilot panel. In this position, the lights were out of range of the pilot's normal scanning pattern, and changes in the mode status could not easily be detected. Relocation of the mode advisory lights to a position within the pilot's normal scanning field of view is desirable for improved helicopter operation.

90. As shown in photograph C, a cruise guide indicator (CGI) was mounted on the pilot panel to provide cockpit indications of the stress loads on the flight control system. The indicator face was divided into two color bands and a "barber pole" band. The two color bands, green and yellow, indicated allowable steady-state and transient loads, respectively, while the "barber pole" range indicated stress loads beyond allowable limits. A self-testing circuit was provided to check static calibration of the device. The CGI was useful to the pilot during maneuvering flight, especially when operating at heavy weights. The instrument was easily monitored in flight; and, under circumstances in which high load readings occurred, the pilot was able to quickly take corrective action to reduce the indicator reading.

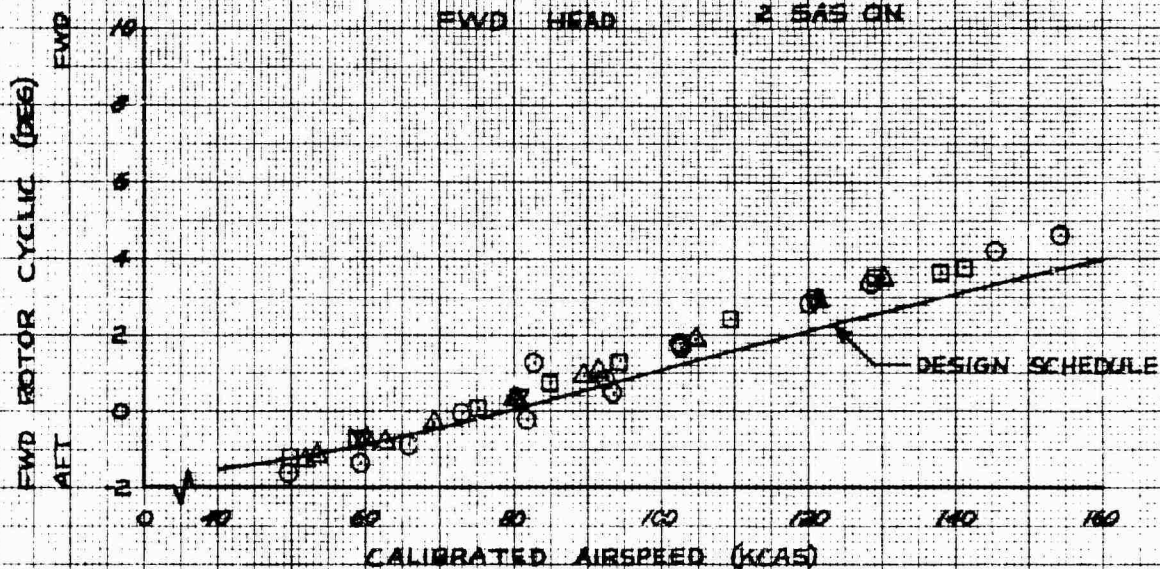
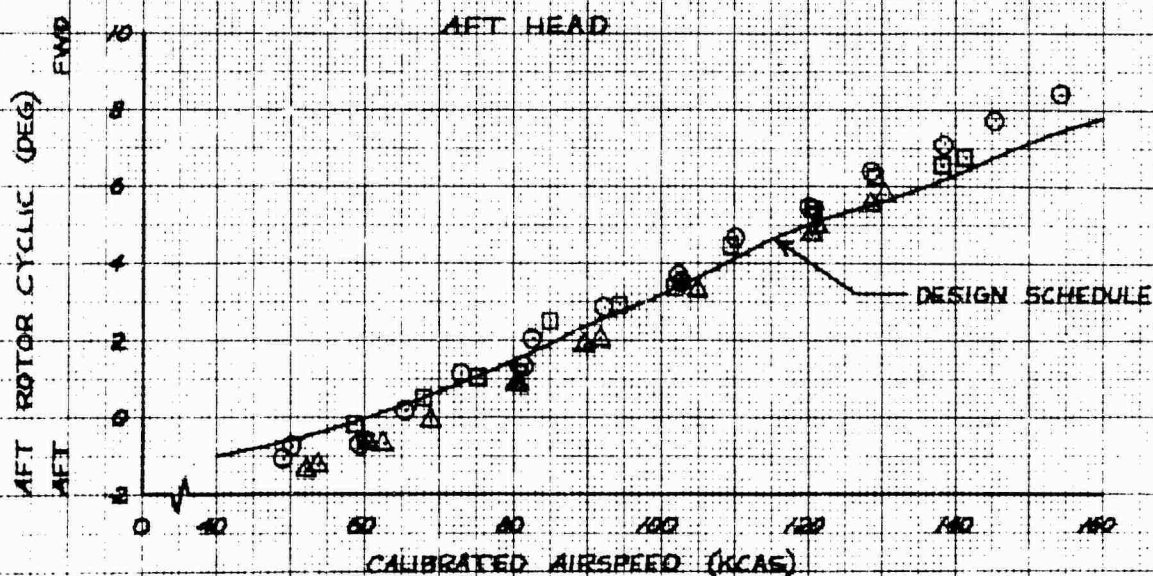
FIGURE 16. LONGITUDINAL CONTROLLABILITY

29. Longitudinal controllability characteristics are presented in figures 16 and 17, appendix II. Longitudinal control sensitivity (maximum angular acceleration) varied from a minimum of 5 deg/sec² per inch of control displacement in hover to a maximum of 13 deg/sec² per inch of control motion in forward flight at 131 KCAS. In hover, this was approximately one-half the sensitivity reported for

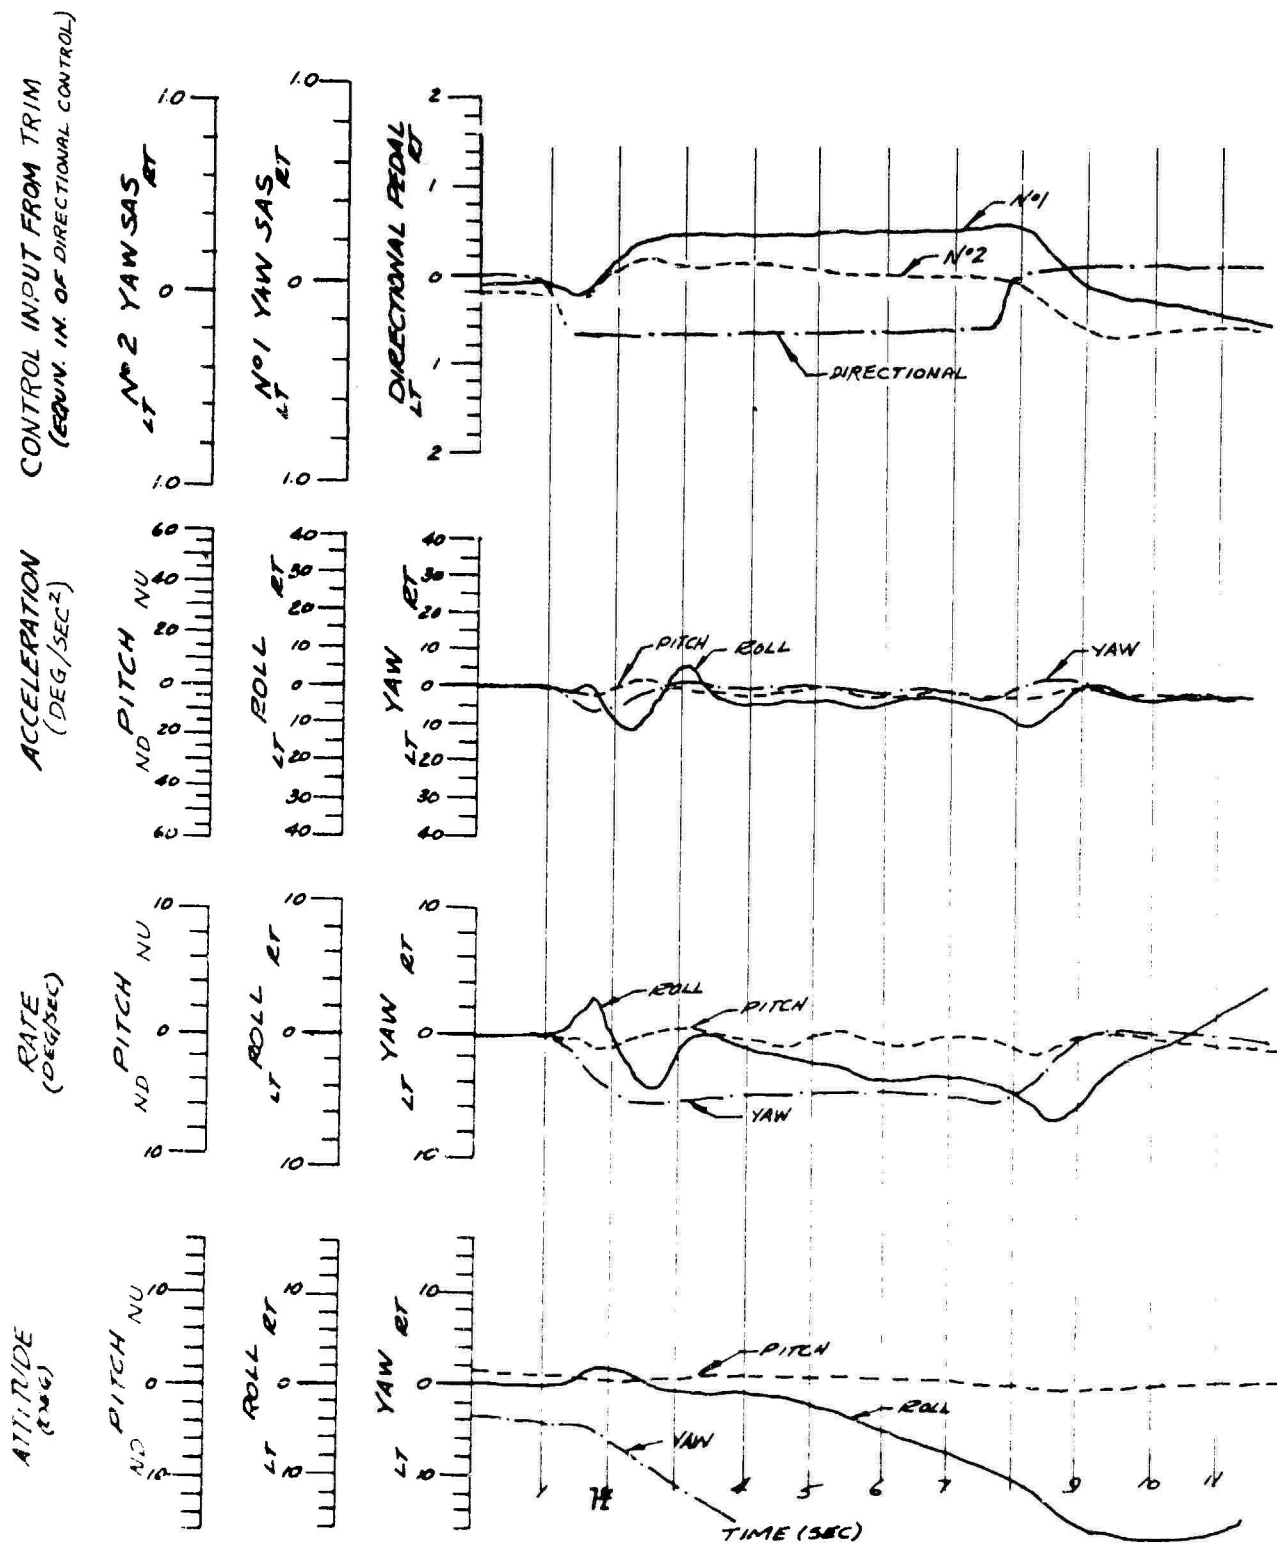
FIGURE 23 AIRCRAFT RESPONSE FOLLOWING RIGHT LATERAL TRIM INPUT
BOEING 347

35. During the original evaluation, continuous operation of the lateral beep trim in forward flight produced long-term bank-attitude changes of approximately 3 degrees for each second of beep operation. Momentary operation of the lateral beep trim produced excessive initial roll acceleration and roll rate, and a transient bank-angle displacement which was subsequently washed out. A time history of a 1/4-second right lateral beep input is presented in figure 23, appendix II. In this case, the 1/4-second beep produced a transient right roll displacement of 2 degrees approximately 1 second after the start of the beep input. Five seconds after applying the lateral beep, the roll attitude returned to and stabilized at a 1/2-degree right displacement. The high initial roll acceleration and roll rate accompanying the lateral beep operation, together with the overshoot of the long-term attitude displacement, adversely affected the pilot's ability to make small

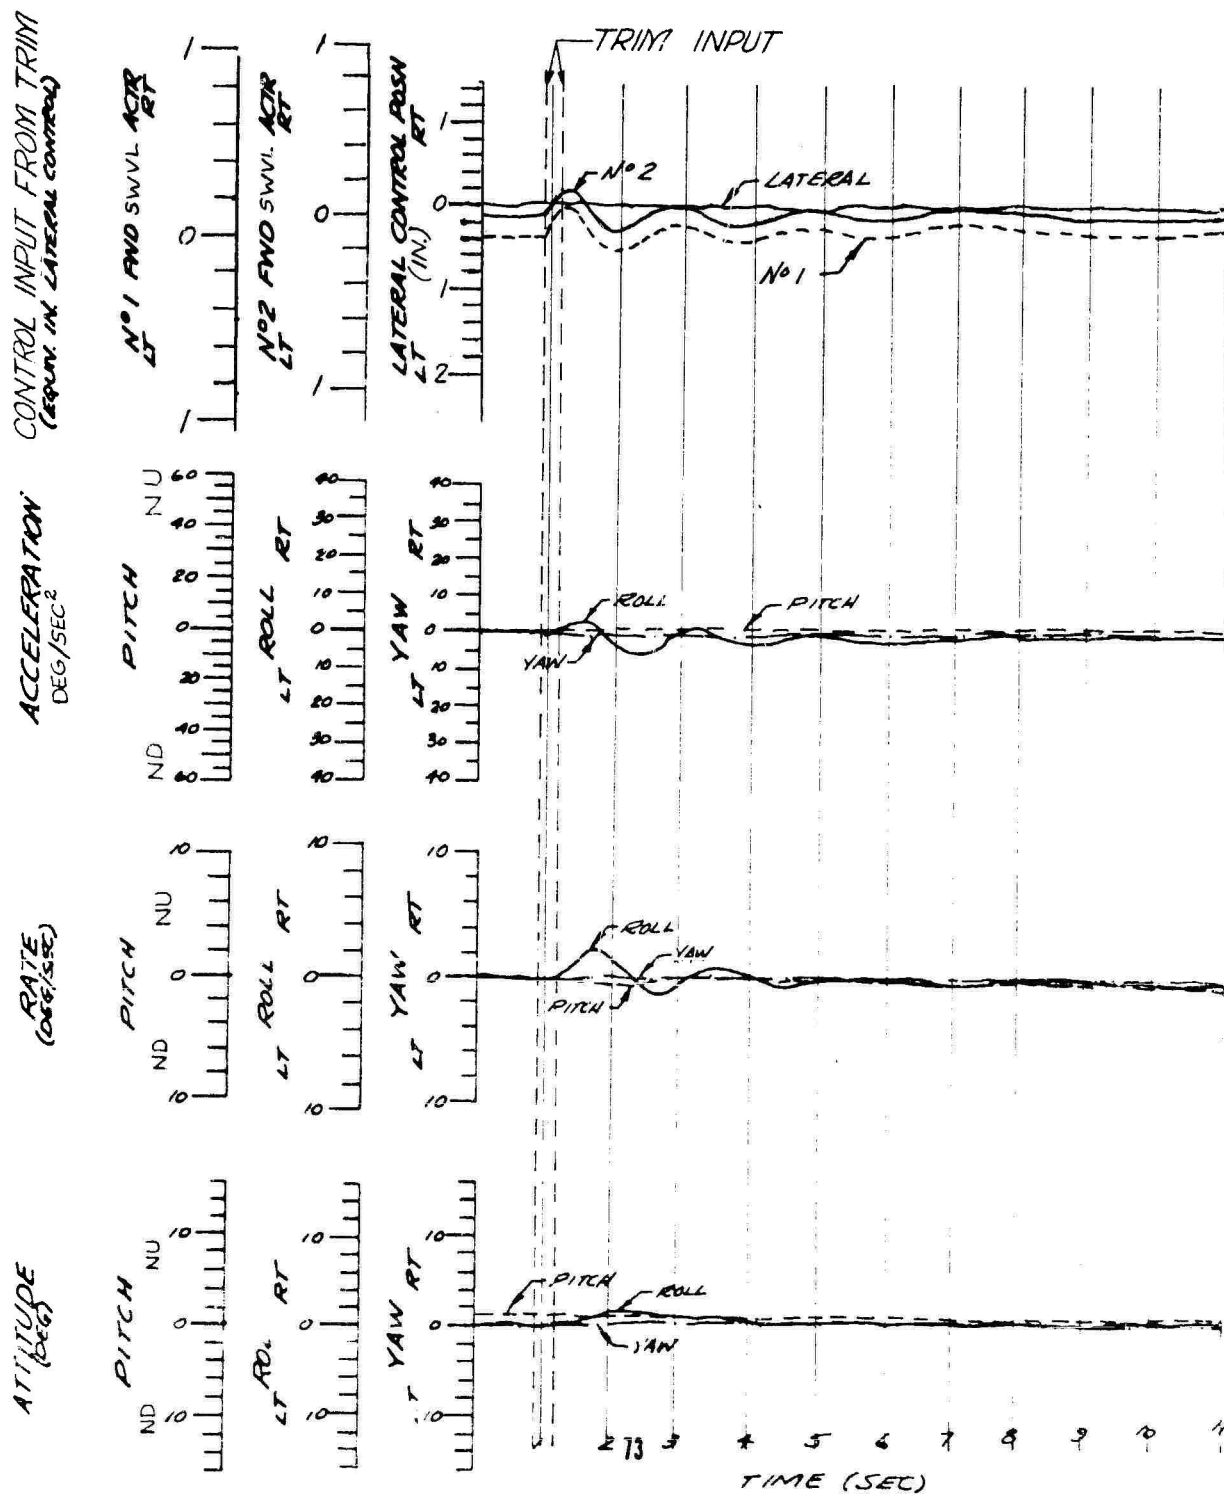
FIGURE 24 AIRCRAFT RESPONSE FOLLOWING RIGHT LATERAL TRIM INPUT

36. Prior to the reevaluation of the aircraft, the contractor modified the lateral beep circuitry to reduce the initial roll response and to reduce the long-term trim rate. Figure 24, appendix II, is an example of the aircraft response to a 1/4-second lateral beep obtained during the reevaluation tests. Although the roll acceleration and roll rate were oscillatory, as in the original evaluation, the oscillations were not objectionable. The roll attitude response was essentially deadbeat to the new long-term attitude with no perceptible overshoot. Operation of the lateral beep trim was very natural, and small trim changes could be easily accomplished with a single lateral beep input (HQRS 2). Continuous operation of the lateral beep trim produced a bank-attitude change of 1.6 degrees for each second of beep operation at all forward flight speeds. The lateral trimmability characteristics observed during the reevaluation test are satisfactory for the transport mission.

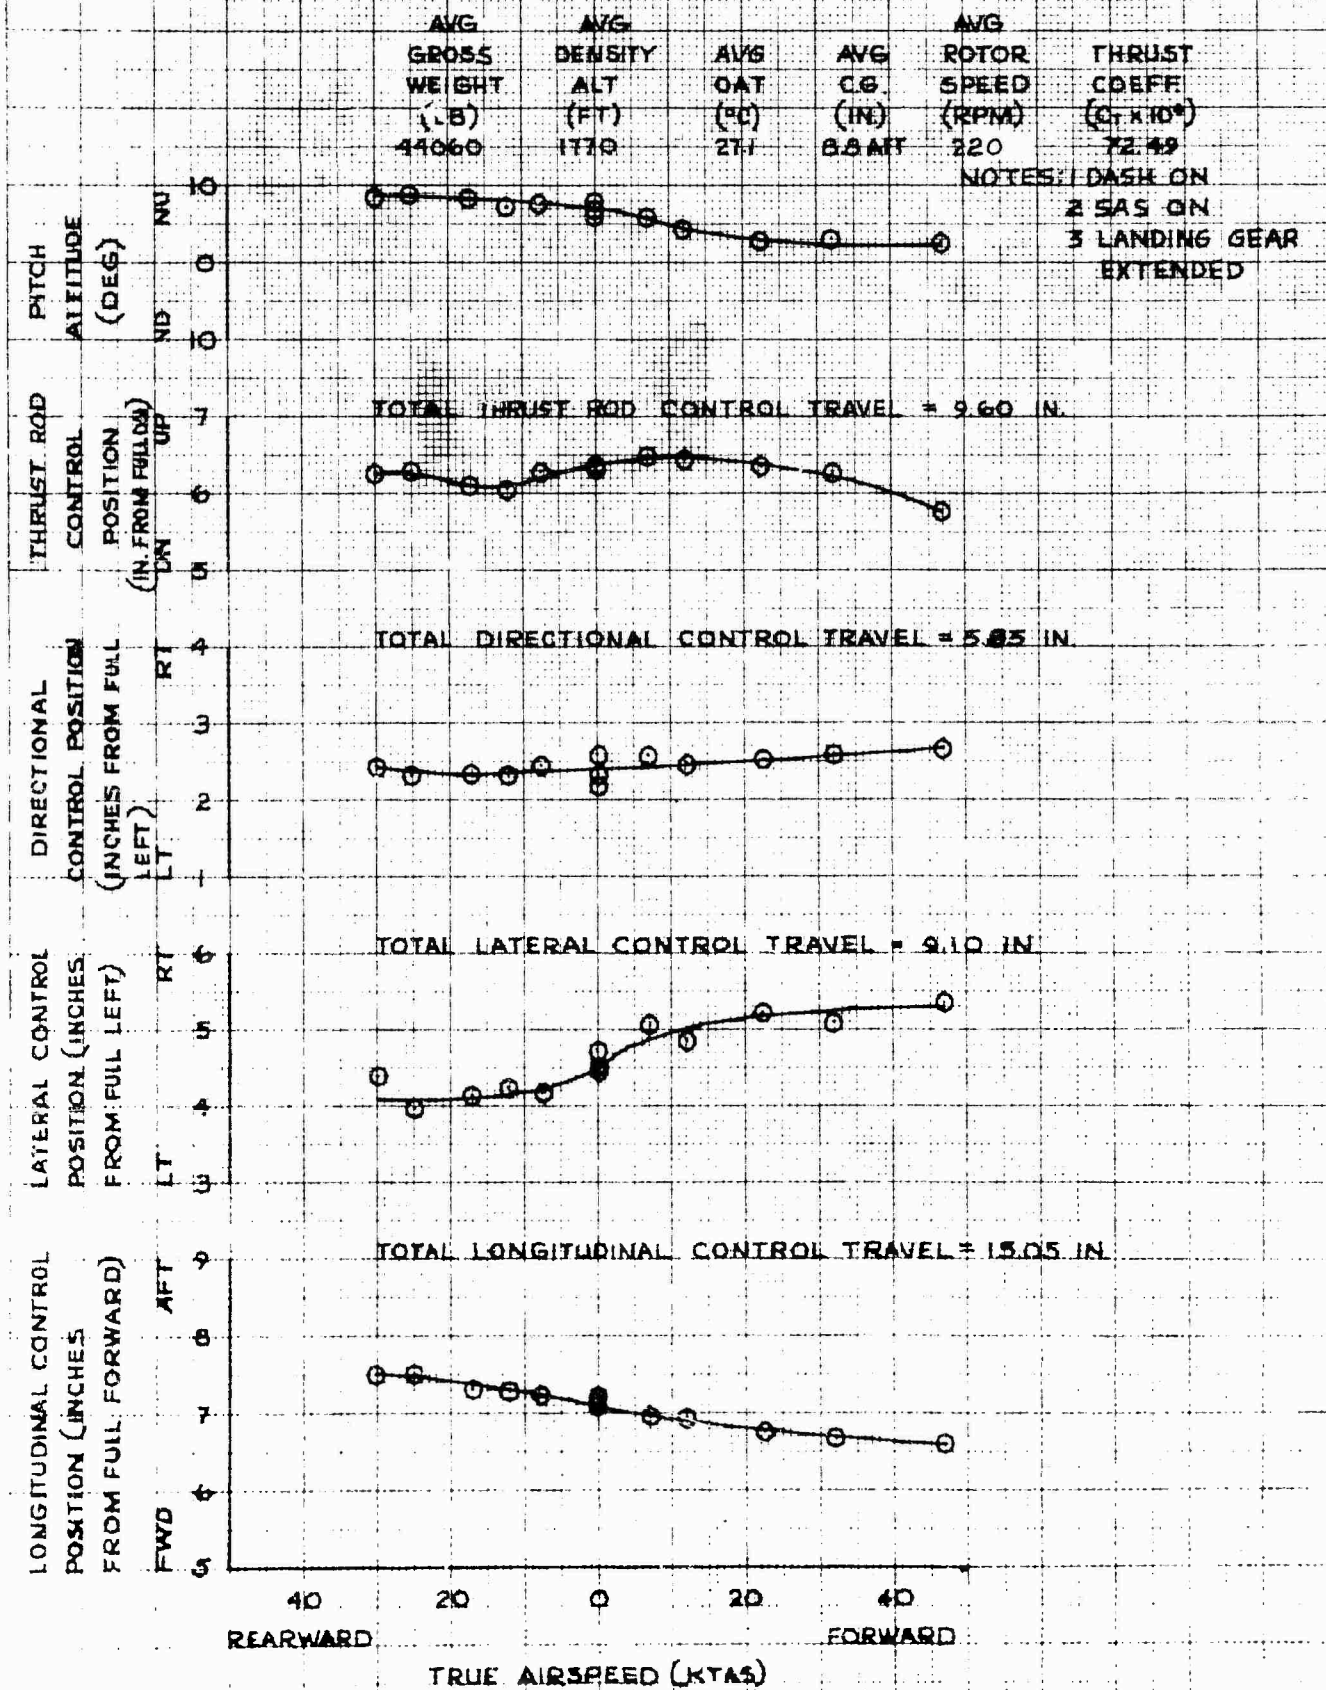
FIGURE 2.6 TRIM CONTROL POSITIONS IN SIDELAND FLIGHT

47. Control positions and bank attitude in sideward flight are shown in figure 26, appendix II. The lateral control gradient in sideward flight was strongly positive (increasing lateral control displacement in the direction of flight) to 15 KTAS and slightly positive to neutral at higher speeds. This lateral characteristic, together with the essentially neutral longitudinal and directional trim gradients, provided good sideward flight characteristics. Steady sideward translation over relatively large distances could be accomplished with very minor and infrequent control inputs. Hovering over a spot in steady crosswinds with controls fixed was possible for periods of up to 10 seconds (HQRS 2). The minimum control margin remaining in sideward flight was 37 percent of lateral control at 30 KTAS in left sideward flight. The sideward flight characteristics of the Model 347 helicopter met the requirements of paragraph 3.3.2 of MIL-H-8501A and are satisfactory for the transport mission.

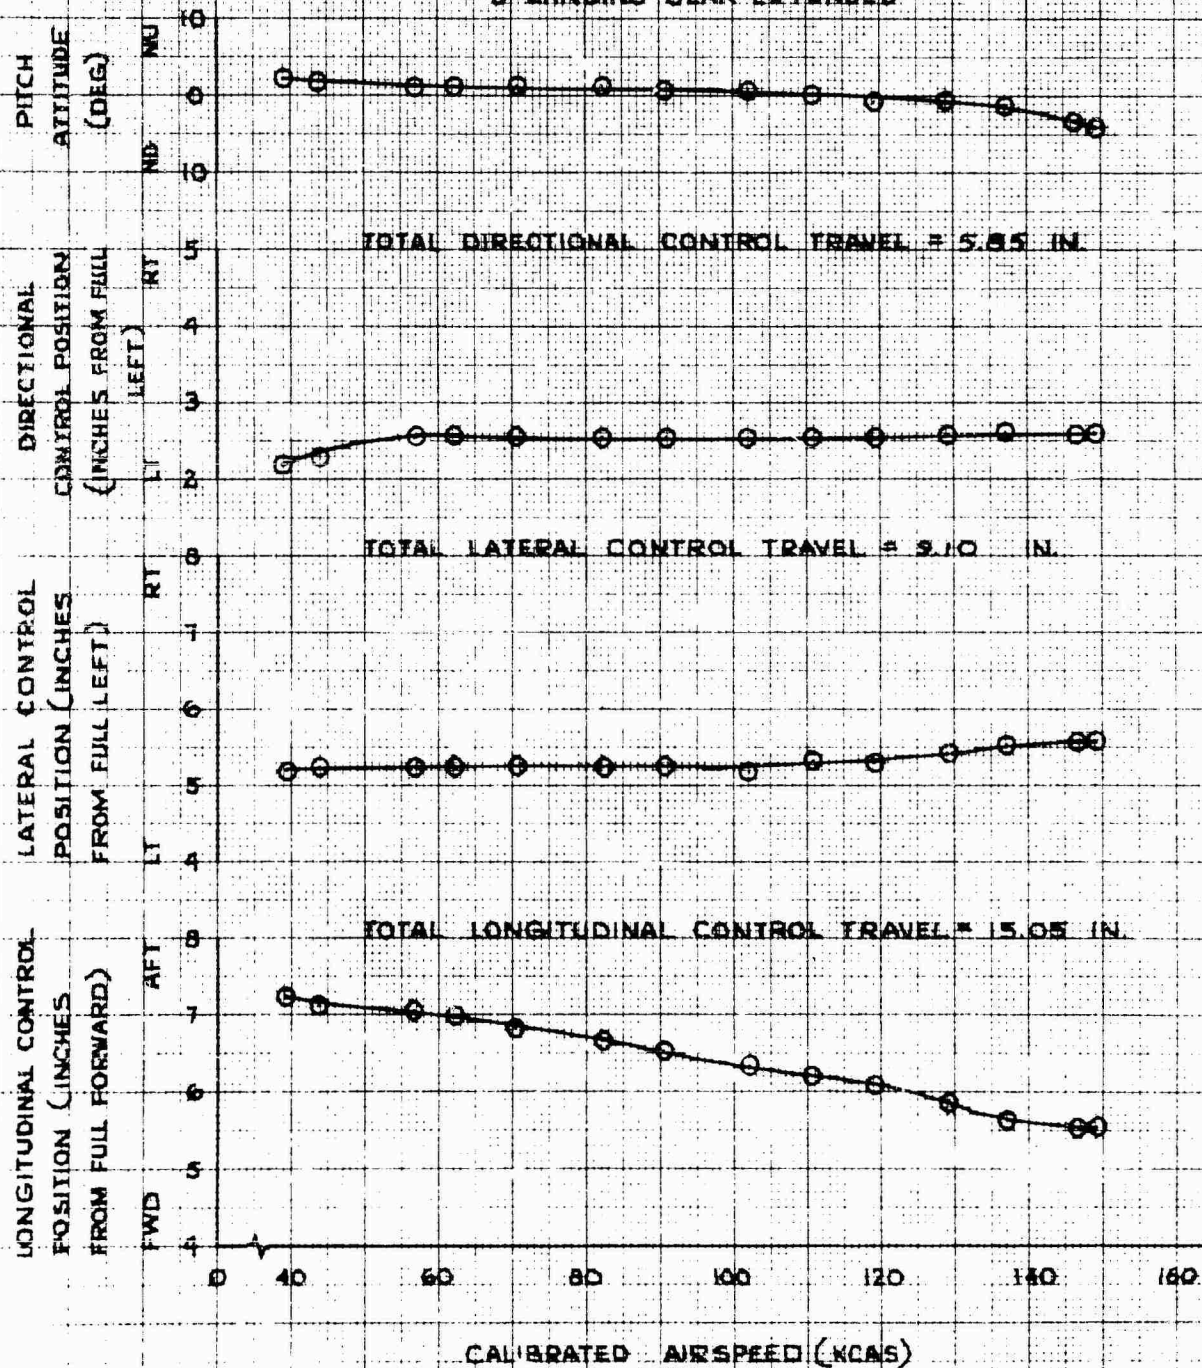
FIGURE 30. TRIM CONTROL POSITIONS COMPARISON IN LEVEL FLIGHT.

50. The DASH-OFF longitudinal control trim position data shown in figure 30, appendix II, represent the conditions which would exist if the Model 347 augmentation system were turned OFF at 140 KCAS. If the DASH system were failed OFF at any other trim airspeed, the actual control position variation with airspeed would follow the gradient shown; however, the curve would originate from the DASH-ON trim position appropriate for that trim airspeed. The DASH-OFF gradient was stable below 50 KCAS, unstable between 50 and 120 KCAS, and slightly stable at faster speeds. Compared to the unaugmented CH-47C, the Model 347 longitudinal trim gradient was noticeably improved at high speed. Although flight under DASH-OFF conditions considerably increased pilot workload in trimming, such a dual failure would not preclude safe recovery of the aircraft. Failure of both DASH systems at high speed would create the most adverse condition, in that, by following the DASH-OFF trim gradient during subsequent deceleration prior to landing, the longitudinal control would be required to be trimmed at an unusually far forward position. When both DASH systems were turned OFF while trimmed at 140 KCAS and an aft cg, the stick position was 5.1 inches from full forward. During the subsequent landing approach, while trimmed at 50 KCAS, the control reached its most forward steady-state position, 3.5 inches from full forward. With this control position, the pilot was left with very little available arm reach with which to counteract nose-up gust disturbances or to apply other necessary forward control movement. It is recommended that the following "CAUTION" be placed in the operator's manual:

48. Control trim characteristics were evaluated by trimming the helicopter in steady-heading, coordinated level flight at 10-knot speed increments from 39 KCAS to VH. Data were recorded for each stabilized condition. Figures 27 and 28, appendix II, present the control position test data obtained during the original evaluation. Figure 29 presents the test data obtained during the reevaluation. The effects of the DASH system on the longitudinal control trim position were determined by measuring the change in the DASH actuator position at each stabilized airspeed and subtracting the DASH actuator equivalent control motion from the actual control position for that airspeed. The resulting DASH-OFF longitudinal trim characteristic data are presented in figure 30. Comparative data for the CH-47C are also shown on this figure.

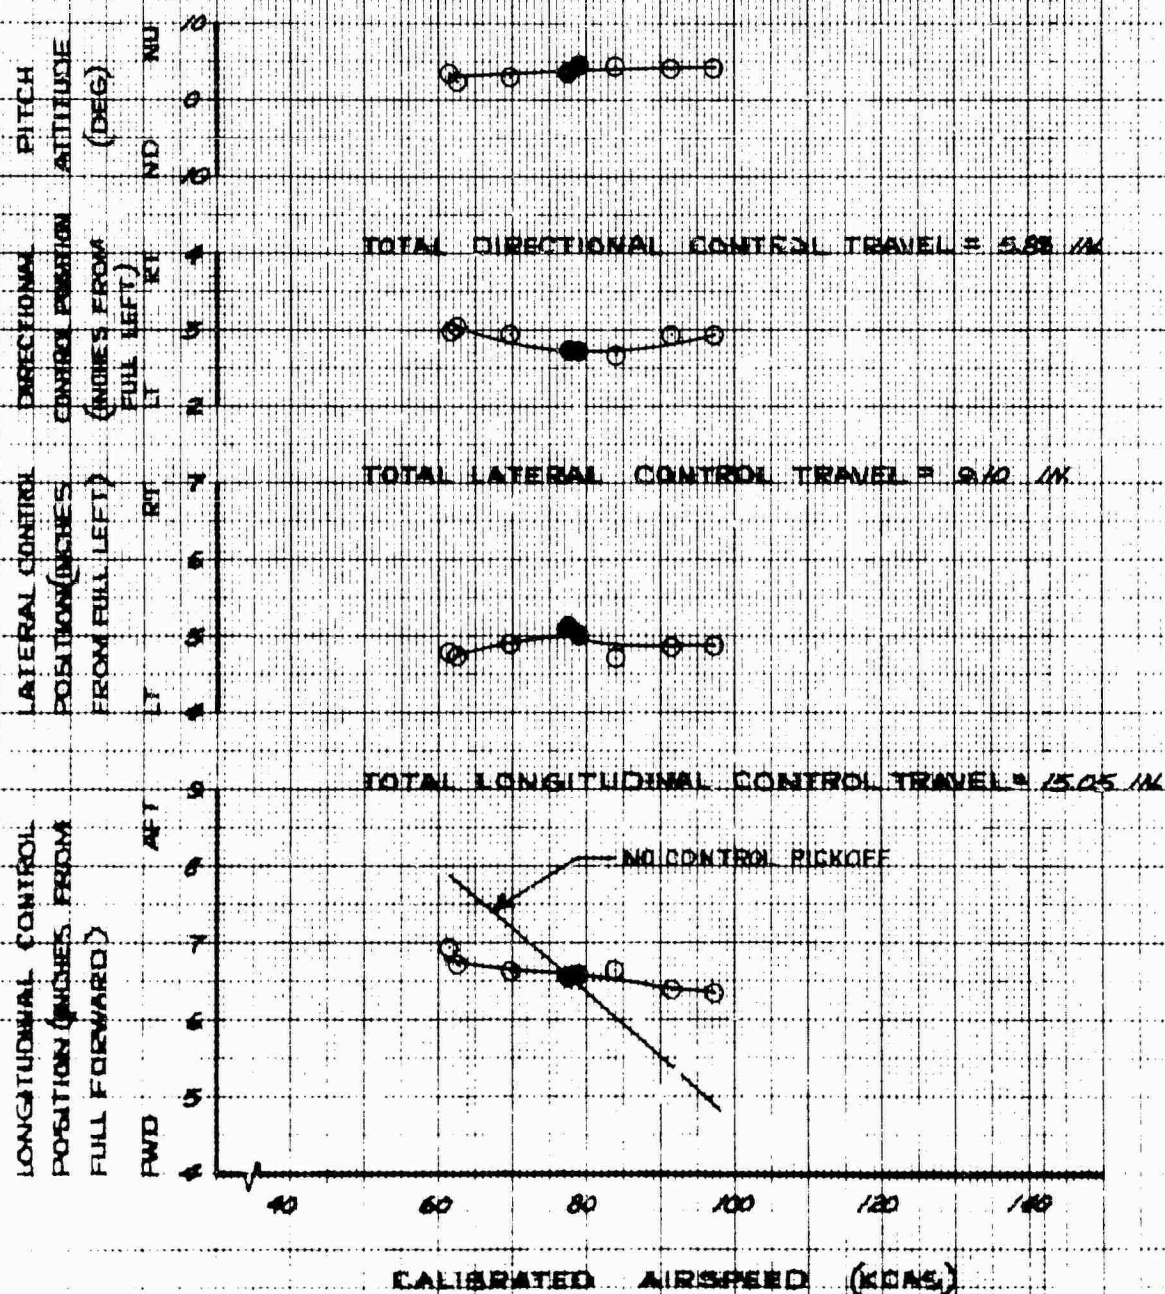
FIGURE 37. STATIC LONGITUDINAL COLLECTIVE-FIXED STABILITY COMPARISON.

56. Static longitudinal stability characteristics with both DASH systems inoperative were determined mathematically by subtracting the DASH actuator motion from the control position data obtained during DASH-ON flight. The results of this computation at a heavy weight, aft cg loading are shown in figure 37, appendix II. A comparison with the CH-47C at similar test conditions is shown on the same figure. Qualitatively, static longitudinal stability with both DASH systems inoperative was neutral to unstable within the airspeed range of 50 to 120 KCAS and was stable at speeds above and below the range. Although flight with both DASH systems inoperative increased pilot workload significantly and required moderate pilot compensation to maintain airspeed and attitude, such a dual failure would not preclude safe continued operation of the helicopter under visual-flight-rule (VFR) conditions.

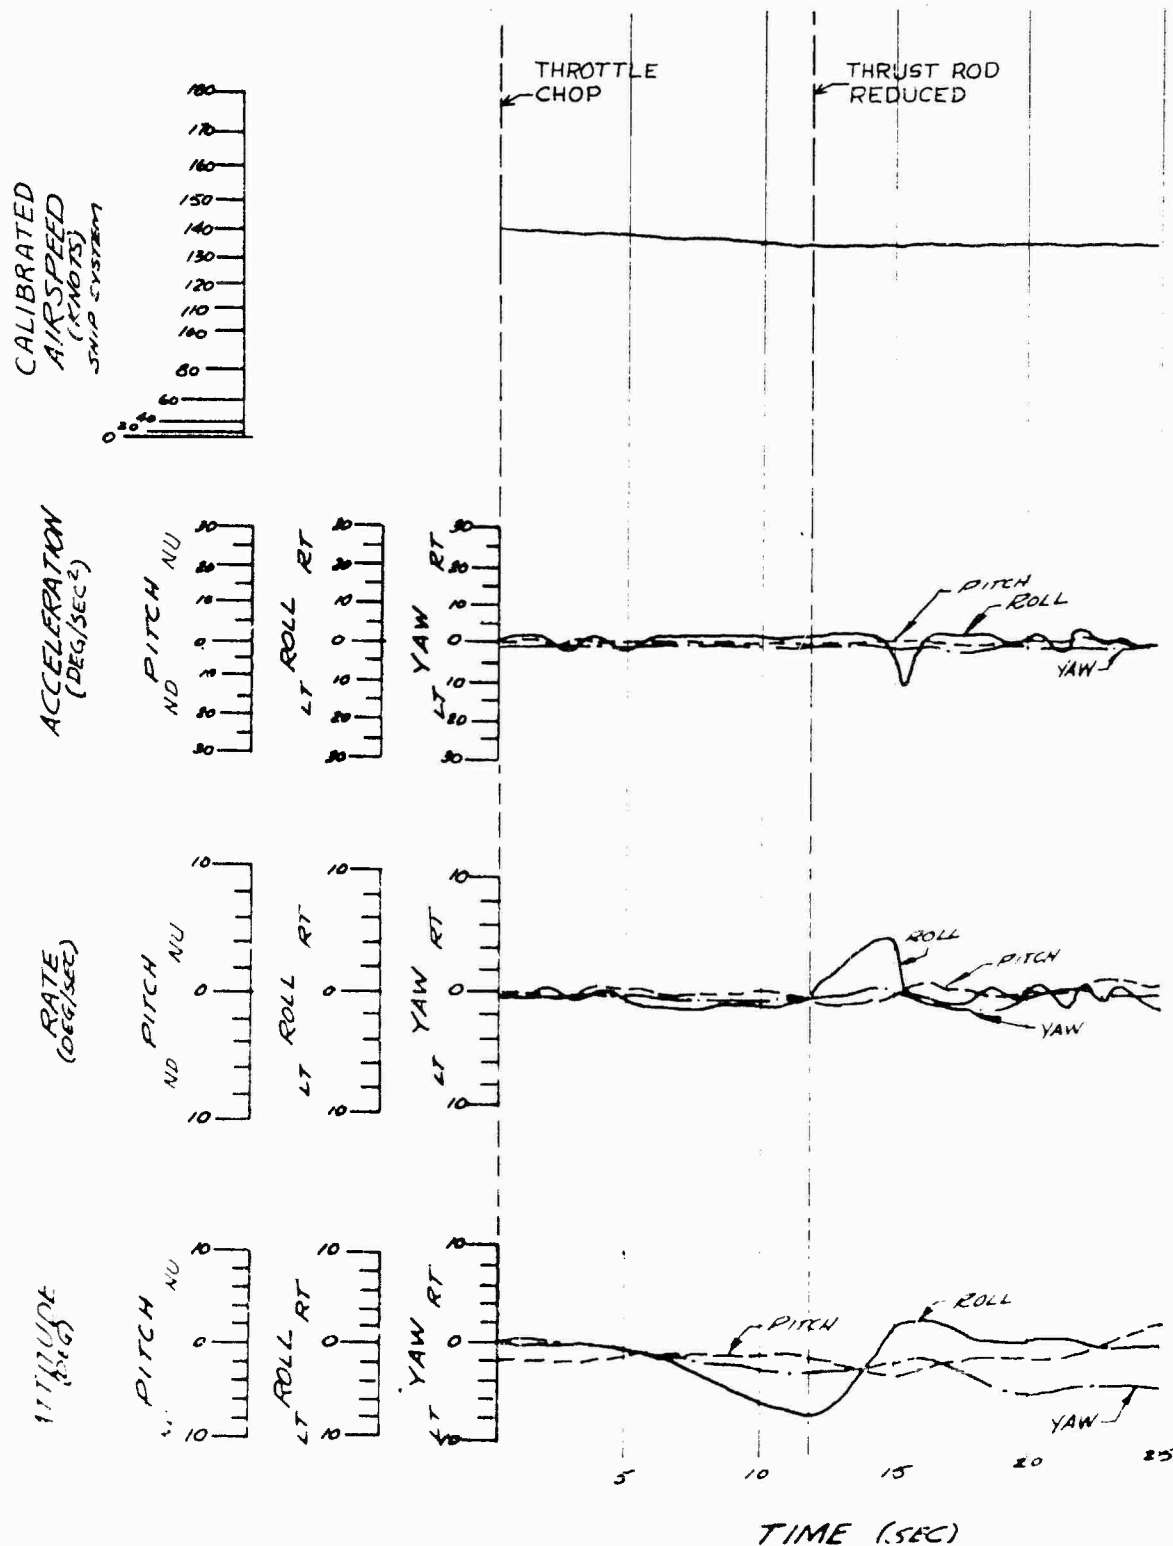
FIGURE 77. AIRSPEED CALIBRATION.

- NOTES.
1. SAS ON
 2. DASH ON
 3. TEST POINTS OBTAINED USING GROUND SPEED COURSE METHOD
 4. LANDING GEAR RETRACTED

102. Because of the lack of an existing airspeed calibration, the ship's airspeed system was calibrated during the course of the evaluation. A measured ground course was used for this purpose. The results of this test are presented in figure 77, appendix 11. The variation of indicated airspeed with calibrated airspeed was essentially linear over the tested airspeed range of 46 to 169 KIAS. The position error was zero at 110 KIAS, approximately 5 knots at 50 KIAS, and -4 knots at 169 KIAS. The position error characteristics of the ship's airspeed system are satisfactory.

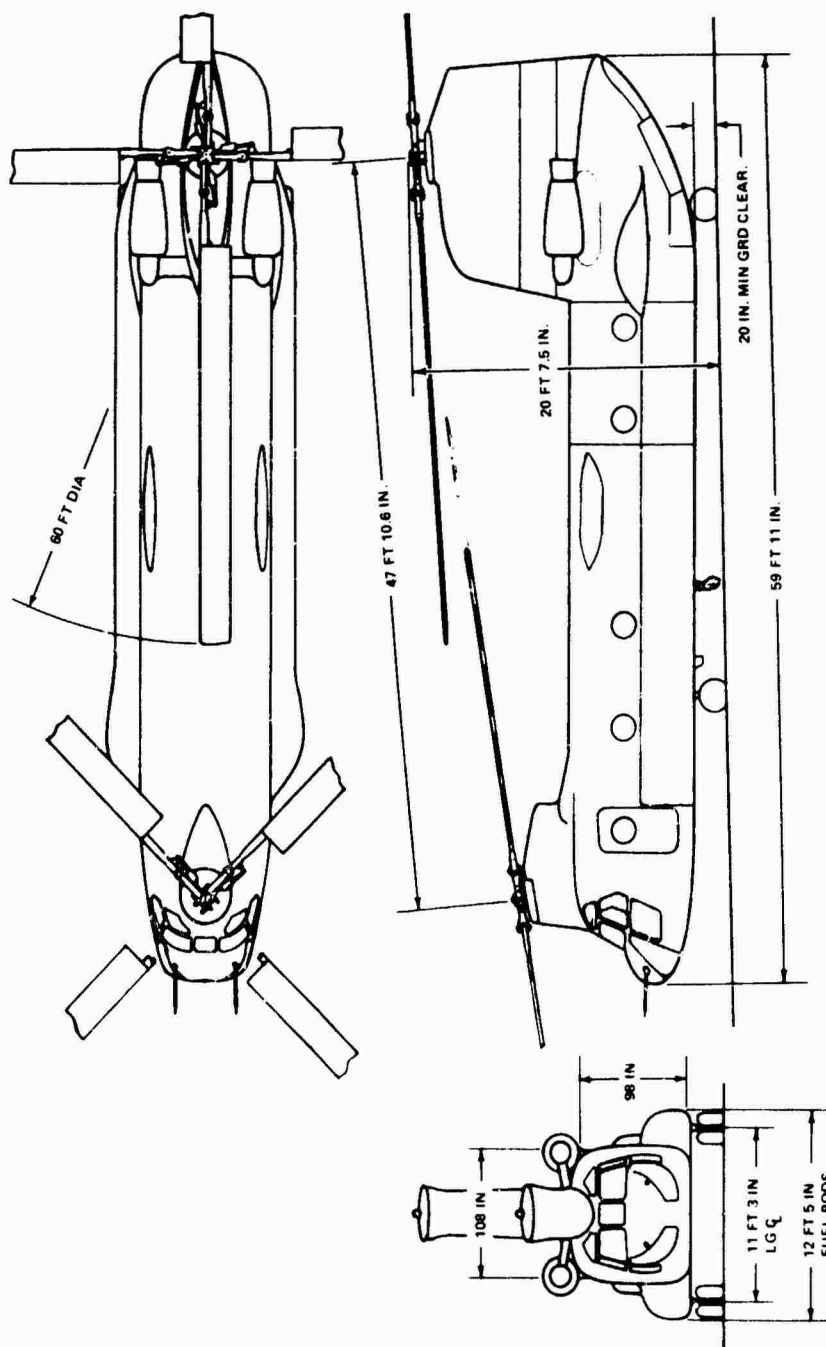
Three-View Drawing of the Model 347 Helicopter.
